Godet coating as customer service

The positive aspects of orange peel skin

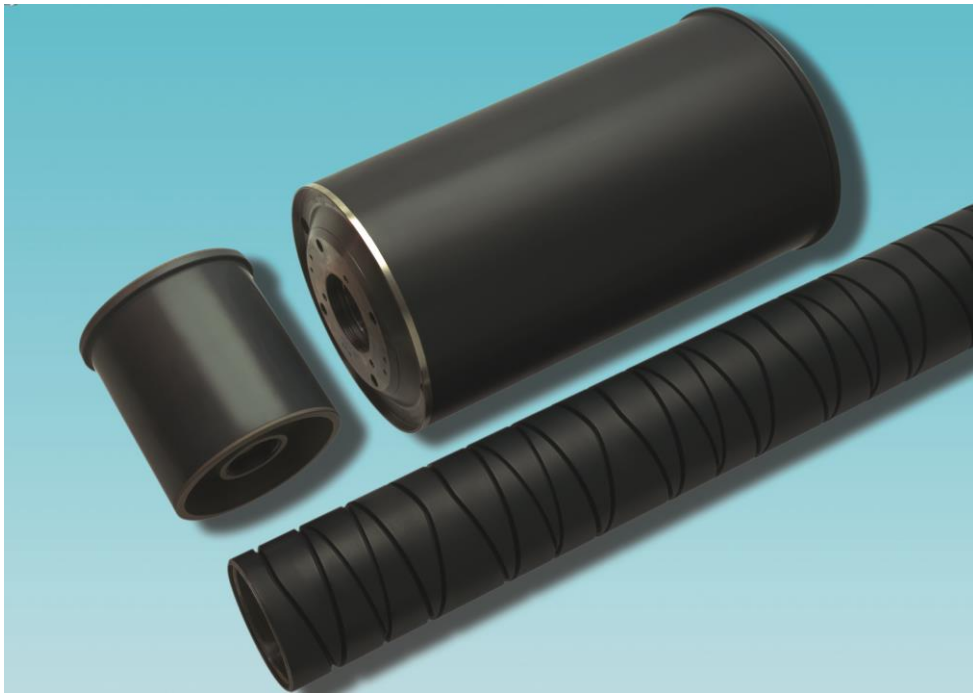
Caption:
Godet or groove roller shells can benefit from a repair coating.

Although the surfaces of such coatings may be precisely tailored to the respective processes and products, they do however deteriorate sooner or later – depending on the polymers, spinning processes and process speeds in question. And aggressive alkali cleaning agents can soften the coating over time. To this end, the result can be under-surface corrosion with blistering, which may cause flaking in the worst case.

In such situations, Oerlikon Barmag offers repair coatings, for which it has been collaborating with surface specialist Oerlikon Metco for more than 30 years now. The affiliate has a presence in the primary Oerlikon Barmag markets across the globe. “Together, we restore the original surfaces with all the required tolerances. Depending on the customer request and market requirements, we can also add different qualities or surfaces – for example, hard plasma coatings”, states Marcus Köhler.
